MEMORANDUM

TO: Elizabeth Hughes, Town Planner
COPY: Alan Cathcart, Acting Director of Public Works
VIA: Steve Dookran PE, Town Engineer
FROM: Justin Richardson PE, Assistant Town Engineer
SUBJECT: 246 Old Road to Nine Acre Corner: Concord Country Club Earth Removal Special Permit

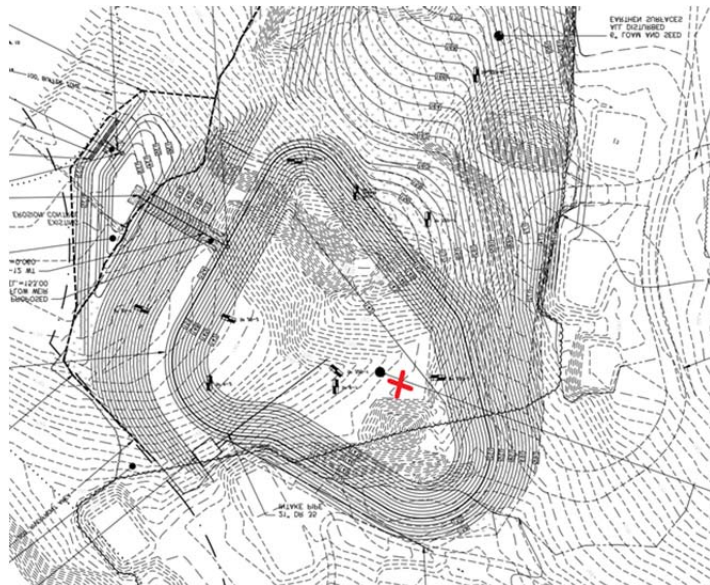
- 1. TP 6-1 is not located in the correct location. The correct location shown below, is located immediately adjacent to the earth pile that is shown on the existing topographic plan below.**

Further confirmation of the hole locations are from pictures from the June 2, 2020 site visit and A level run that was performed by Onyx Corporation prior to the hole being dug which specified an elevation of 155.10'. This has considerable effects to the design setting the seasonal high ground water elevation at 139.10'. Pursuant to Zoning Bylaw Section 7.6.6.11,

removal of soil, loam, sand, gravel, or any other mineral substance within four feet of the historical high groundwater table elevation is prohibited within the Groundwater Conservancy District.

- **The location of TP 6-1 needs to be moved in the east to be immediately adjacent to the pile located on the existing conditions plan and above the 155.00' contour. Please revise to the plans to show the test hole in the appropriate location. Engineering concurs that the bottom of the basin in this area is more than 4' above seasonal high groundwater. (discussed in the 12/9/2020 meeting)**

- *The location of TP 6-1 and its elevation have been corrected. The pond bottom has been revised to hold a minimum of 4' to the estimated seasonal high groundwater table.(11/17/2020)*

- *The location of TP 6-1 has been corrected.(12/15/2020)*
 - **Comment has been addressed (12/31/2020)**
- 2. **TP 7-2 according to the point description and existing conditions survey is at elevation 154.435'. The soil log is consistent with Engineering's notes from the site visit on July 2, 2020 that season high ground water is located 86-inches measured from the ground surface as the hole location (154.435'). This means that the seasonal high ground water elevation in that area is 147.27', which means that the bottom of the basin is within the four foot to seasonal high groundwater. Pursuant to Zoning Bylaw Section 7.6.6.11, removal of soil, loam, sand, gravel, or any other mineral substance within four feet of the historical high groundwater table elevation is prohibited within the Groundwater Conservancy District.**
