Application for a Certificate of Appropriateness

Property Address: 245, 249 + 255 LEXINGTON RD Map#: H-9 Parcel #: 0028-245-14

The Benjamin Barron Condominium, Lexington Road, Concord
Project Narrative for Chimney Caps

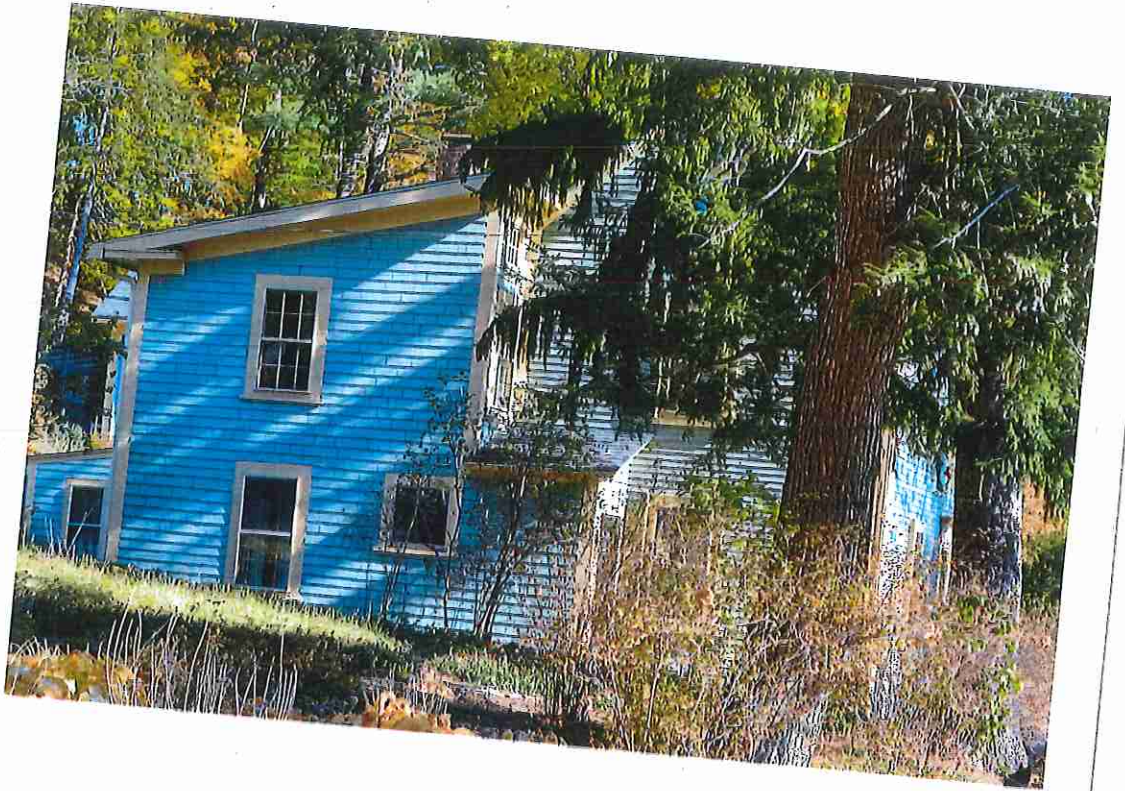
#1-- at the rear, supports 1 fireplace, has a cap that is rusted and of insufficient size

16 x 16 x 10 inches

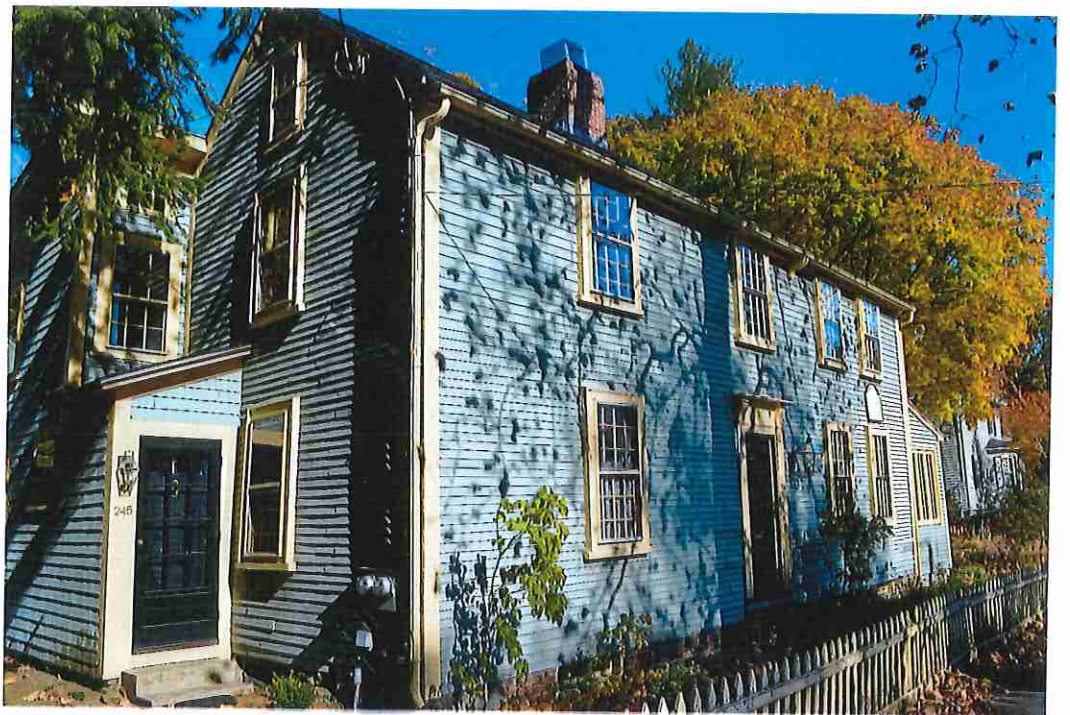
#2 -- at the front, supports 4 fireplaces, has a mesh animal guard and has a history of water coming in the attic

29 x 30 x 10

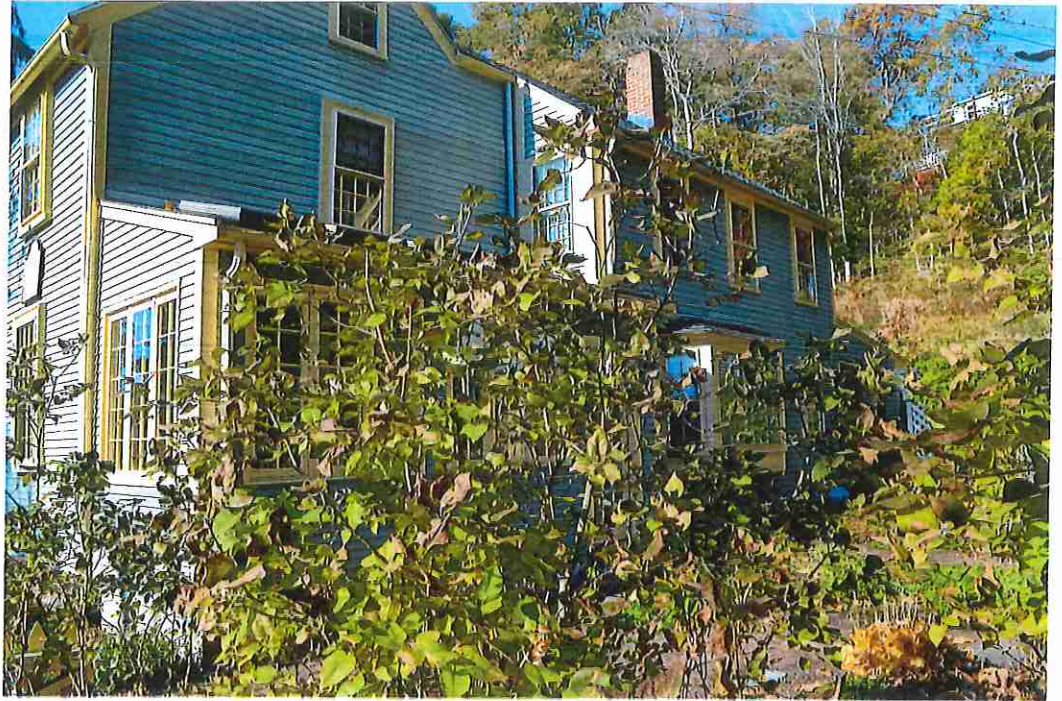
#3 -- at the rear, supports 2 furnaces and has no cap

16 x 12 x 10

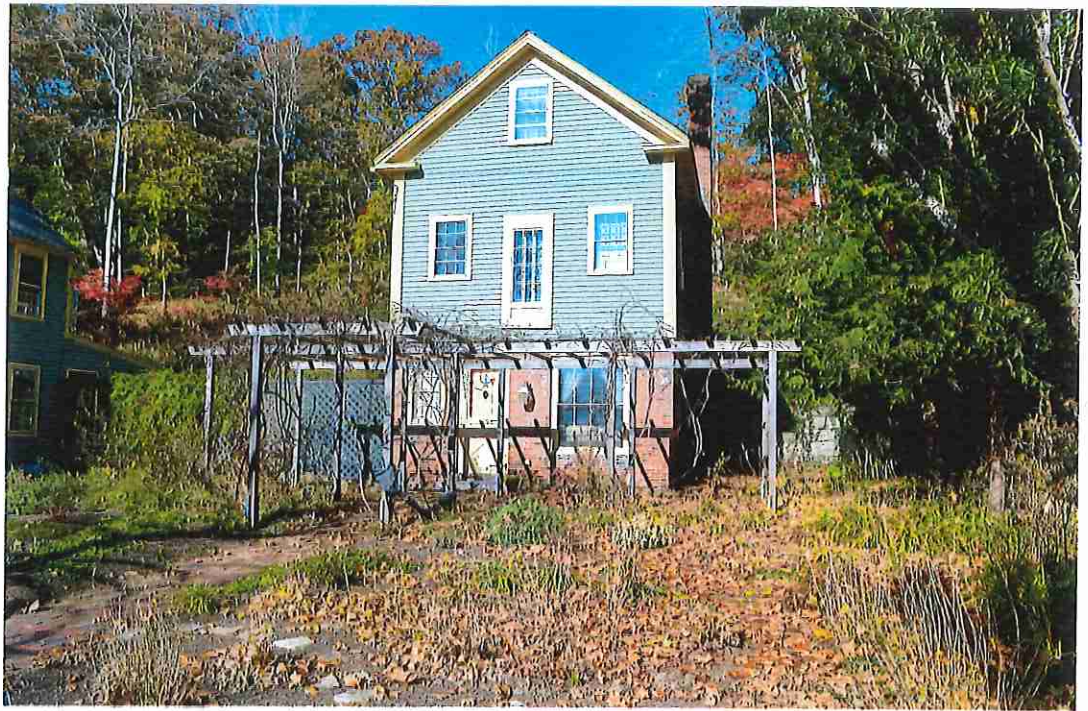
#4 -- at the right side of the second building, has no cap and has a history of water coming in the fireplace

17 x 29 x 10
